Evaluating Driver and Pedestrian Behaviors at Enhanced, Multilane, Midblock Pedestrian Crossings

Case Study in Portland, Oregon

Transportation Research Record: Journal of the Transportation Research Board, No. 2464, Transportation Research Board of the National Academies, Washington, D.C., 2014, pp. 59–66.
DOI: 10.3141/2464-08

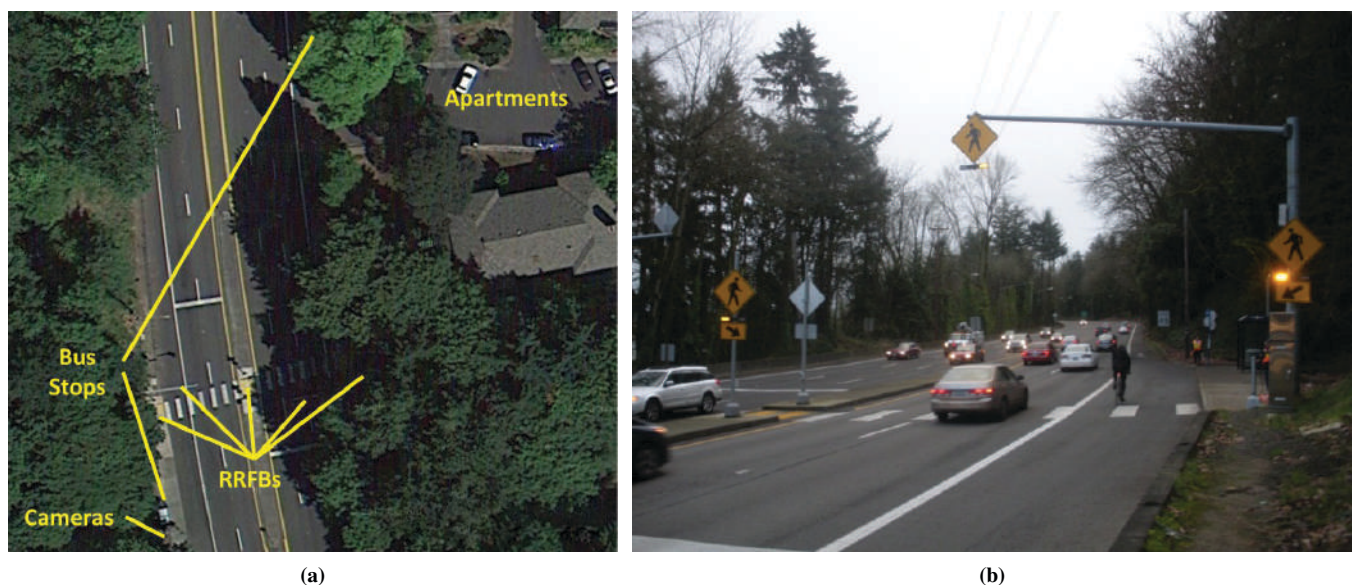
FIGURE 1 Observed crosswalk on Southwest Barbur Boulevard: (a) plan view and (b) crossing [road section has five travel lanes and median island (ADT = 30,700; posted speed limit = 35 mph)]. [Source for (a): Google Maps.]

The observed crosswalk on Southwest Barbur Boulevard (OR 99W) is shown in Figure 1. The Oregon Department of Transportation (DOT) and the regional transit agency, TriMet, installed the enhanced crossing in February 2012. There is high pedestrian crossing activity at this location, with more than 200 activations of the RRFB each weekday, according to data provided by the Oregon DOT. This activity is likely caused by bus stops located on both sides of the highway. There are eight bus routes that stop on both sides of the highway at this crossing. The surrounding area is residential and many of the residents commute via bus transit.

The crosswalk is marked with 9-ft-long longitudinal lines at 5-ft center-to-center spacing (3-ft gap) from curb to curb with a median refuge island. A total of six RRFB assemblies are installed at the crossing location, three facing each direction of traffic. One assembly is located on the side of the road and another is located in the median. The third assembly on each side is installed overhead. There are also two RRFB assemblies in advance of the crossing, one in each direction. The RRFBs are activated by one of four push buttons: one on each side of the road and two in the median refuge area. Each button activates all six assemblies at once. Advance stop bars for approaching motor vehicle traffic are placed approximately 50 ft in advance of the crosswalk, with Stop Here for Pedestrian (R1-5b) signs. The crossing is situated on a horizontal curve and on a grade of approximately 2%.

This section of Southwest Barbur Boulevard has two 11-ft-wide travel lanes and a 10-ft bike lane in the southbound direction. In the northbound direction, there are three 11-ft-wide travel lanes and a 5-ft bike lane. There is a bus pullout in the southbound direction. The total cross-section width is approximately 85 ft, including the bus pullout and the 10-ft median island. The sidewalk on the east side of the road comes from the north and ends at the crossing. On the west side of the road there is a short section of sidewalk connecting the crossing to the bus stop and a dirt trail that connects the crossing and bus stop uphill through a forested slope to Southwest Terwilliger Boulevard.

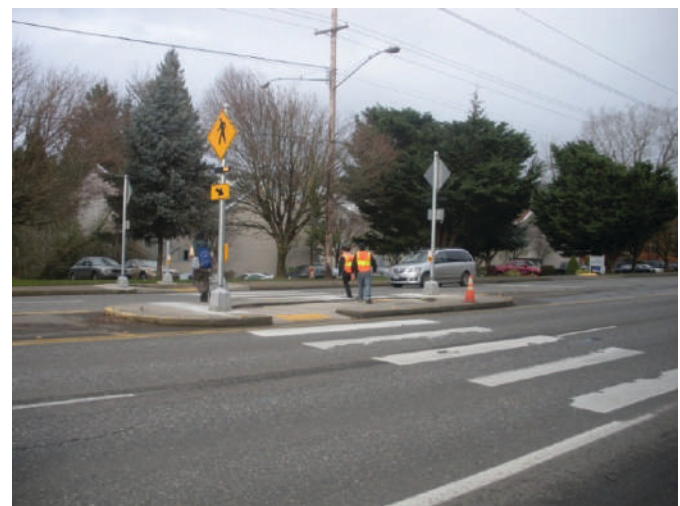
FIGURE 2 Observed crosswalk on Beaverton–Hillsdale Highway: (a) plan view and (b) crossing [road section has four travel lanes and median island (ADT = 26,400; posted speed limit = 40 mph; SW = southwest; ave = avenue)]. [Source for (a): Google Maps.]

The second crosswalk is located on Southwest Beaverton–Hillsdale Highway approximately 225 ft east of Southwest 62nd Avenue, as shown in Figure 2. The City of Portland installed the raised median island and marked crosswalk in 2007 and the RRFB in late 2012. There are nearby bus stops (1,018 boardings and alightings per week in 2011 (13)), apartments, and a large nursing home and respite care center. According to data provided by the City of Portland, there are approximately 120 activations of the RRFB each weekday.

As shown in Figure 2, the crosswalk is marked with 10-ft-long longitudinal lines at 5-ft center-to-center spacing (3-ft gap) and there is a median refuge island that directs pedestrians in a Z-crossing to the second stage of the crossing. Four RRFB assemblies are installed at this location, with one mounted at the edge of the sidewalk on each side of the road and two mounted in the median island so that two assemblies are facing each direction of motor vehicle traffic. The RRFBs are push button activated, with buttons located at each end of the crosswalk, as well as two in the median. The RRFBs are synchronized so that all four assemblies flash when any button is depressed. Pedestrians are also given an audible warning that oncoming traffic may not stop when the RRFBs are activated. Advance stop lines for approaching motor vehicle traffic are placed approximately 50 ft in advance of the crosswalk.

This section of the Beaverton–Hillsdale Highway has two 12-ft-wide travel lanes, a 5-ft bike lane in each direction, and a 14-ft-wide center turn lane, giving it a total cross-section width of approximately 72 ft. There are also sidewalks on both sides of the road that continue beyond the immediate area of the crosswalk.

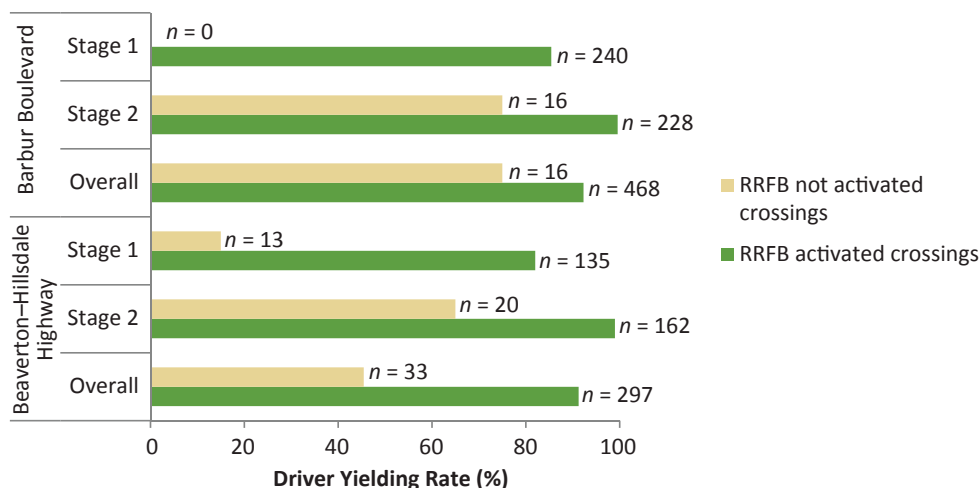
FIGURE 4 Driver yielding rates by RRFB actuation (*n* = number of vehicles).

and pedestrians experienced each stage separately. Figure 4 and Table 1 summarize the observed yielding rates by stage of crossing and RRFB activation.

The figure shows that driver yielding rates increased significantly when the RRFB was activated. The yielding rate for crossings when the RRFB was not activated is comparable to the rate found by Turner et al. for high-visibility crossings (8). The sample size of vehicles present at crossings when the RRFB was not activated was particularly small at the Southwest Barbur Boulevard site, so it was difficult to draw any conclusions from that sample. The Southwest Barbur Boulevard sample only included vehicles in the second stage of the crossing, which tended to have higher yield rates. However, the difference in yielding rates when the RRFB was activated compared with when it was not activated at the Beaverton–Hillsdale Highway site was significant (two-sample z-test of proportions, *p*-value < .001).

Figure 4 also shows that yielding rates were higher for the second stage of the crossing at both sites. This was particularly true for crossings where the RRFB was not activated. The higher yielding rates indicate that delay for pedestrians was most likely to be highest when pedestrians were waiting to cross the first half of the road; pedestrians were not likely to be stranded in the center island waiting to complete the second half of the crossing. This finding was confirmed by the study’s observations, which found that of 299 crossings with the RRFB activated, only one, or approximately 0.3% of these crossings, resulted in a pedestrian stranded (i.e., having to wait longer than 5 s to continue crossing) in the median
