New roundabout with flashing beacons brings pedestrian safety to Maui

Kahului, Maui

6 x R920 RRFB crosswalk systems

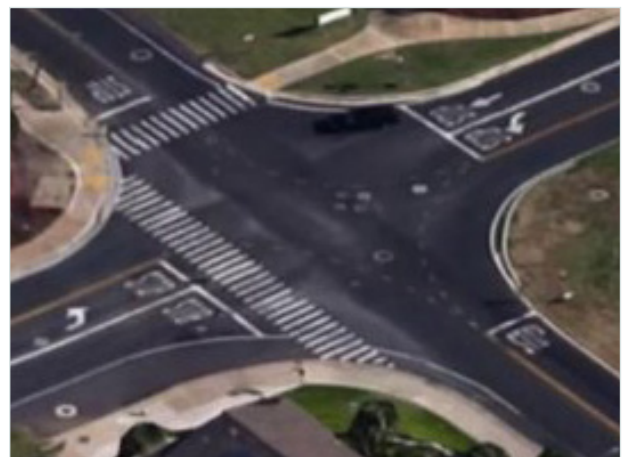
Four-way stop intersection before roundabout installation

As the usage of the intersection intensified, pedestrian safety had become growing and serious community concern. Although pavement markings had been added at two of the four intersection legs, pedestrians—many of them children walking to and from a nearby elementary school—were forced to cross up to three lanes of traffic at a time without any visibility or safety enhancements.
